Manhole Inspection Summary

Manhole # S29AA_017MH

Insp Date: **4/22/09 11:36 AM**

Location Address: **1018 PENNSYLVANIA**

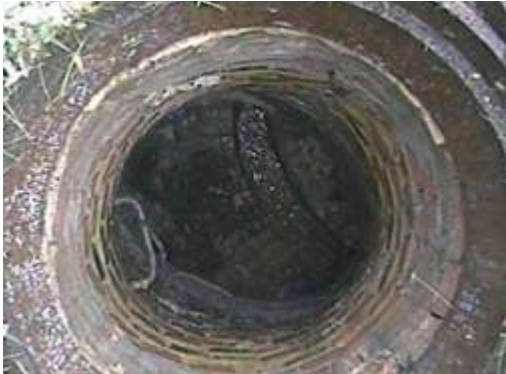
Defect 2

Count: **3** Missing: **0** ☒ **Corroded**

STEPS CORRODED

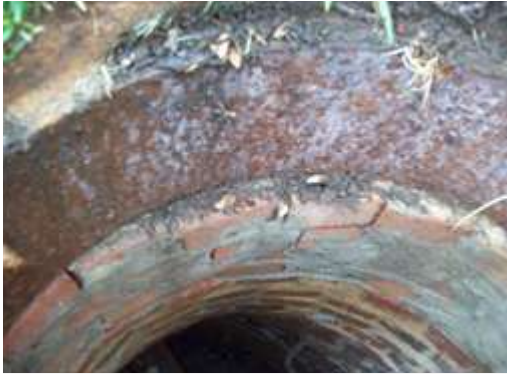
Defect 1

Offset: **2** (in.)

FRAME OFFSET

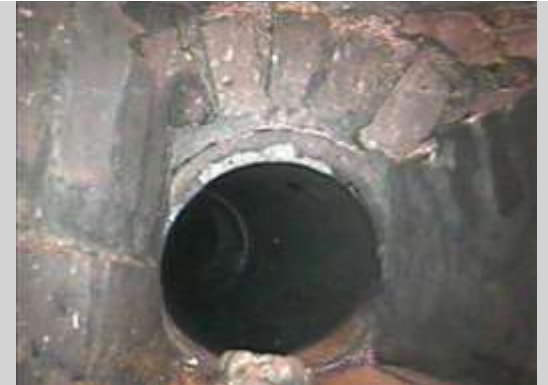
12 O'Clock Outflow

8 in. Circular Gravity Sewer
Pipe Out @ 12 O'Clock

Pipe Height: (in.) Direct
Pipe Material: **Clay** ☐ Pipe Lined
Invert Depth: **8.40** (ft.) Flow Characteristics: **Slow**
Deposits: ☒ None ☐ Mud ☐ Sludge ☐ Debris ☐ Grease
Silt Depth: (in.) Deposits Extent:
Infiltration: **None** Pipe Seal Cond: **Sound**

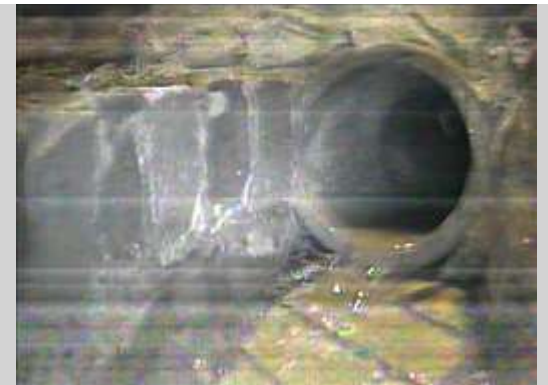
7 O'Clock Inflow

6 in. Circular Gravity Sewer
Pipe In @ 7 O'Clock

Pipe Height: (in.) Direct
Pipe Material: **Clay** ☐ Pipe Lined
Invert Depth: **8.10** (ft.) Flow Characteristics: **Slow**
Deposits: ☒ None ☐ Mud ☐ Sludge ☐ Debris ☐ Grease
Silt Depth: (in.) Deposits Extent:
Infiltration: **None** Pipe Seal Cond: **Sound**
